Manhole Inspection Summary

Manhole # S2100_020MH

Insp Date: **7/10/07 8:30 AM**

Location Address: **2880 LYNBROOK-RUSKIN**

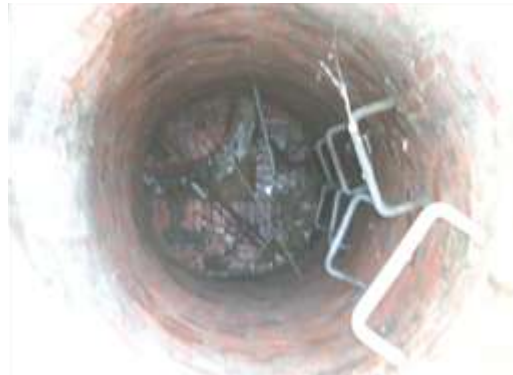
Top View

DEBRIS ON BENCH

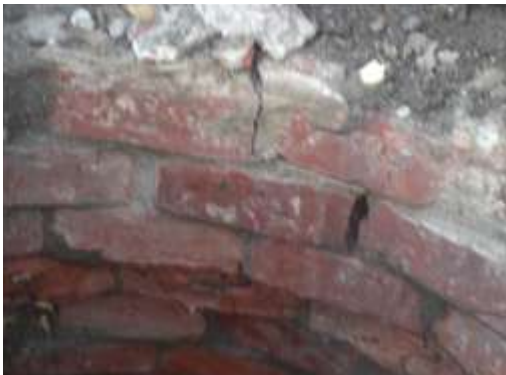
Defect 3

Condition: ☐ Sound ☒ **Cracked** ☐ Root Intrusion ☐ Loose Brick ☐ Deteriorated

CRACKED BARREL

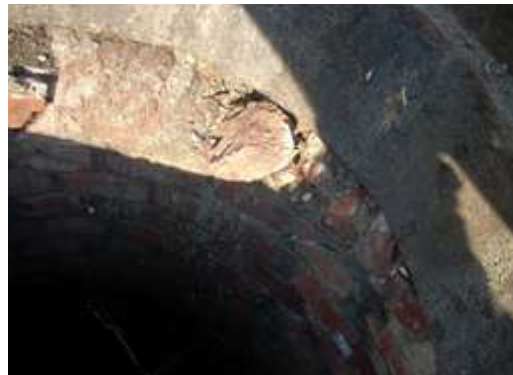
Defect 2

Condition: ☐ Sound ☒ **Cracked** ☐ Root Intrusion ☐ Loose Brick ☒ **Deteriorated**

DETERIORATION OF CORBEL

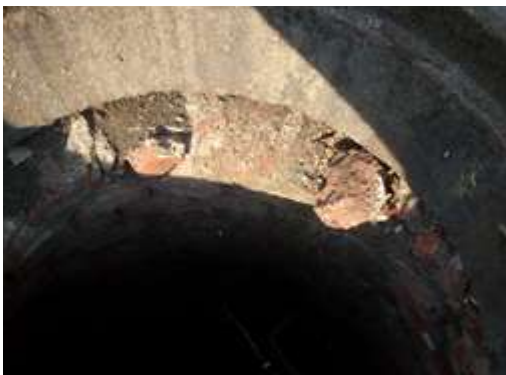
Defect 1

Frame Offset: **4** (in.) Condition: ☒ Sound ☐ Cracked ☐ Leaks

FRAME OFFSET
